Stream Vegetation & River Herring

Russ Cohen, Rivers Advocate

Mass. Department of Fish and Game

Presented at the 4th Annual Meeting of the River Herring Network

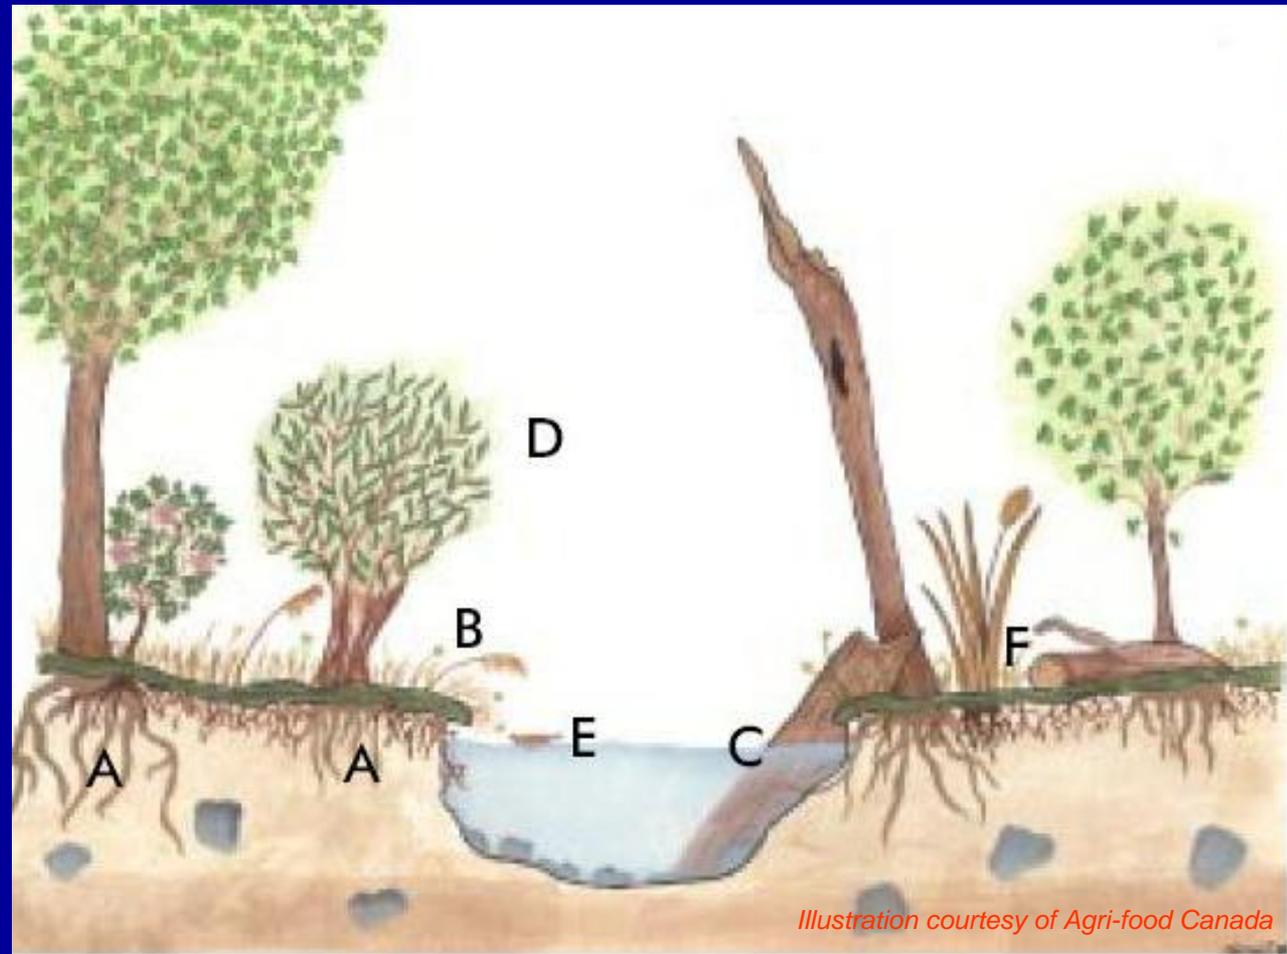
Illustration courtesy of Agri-food Canada

Water Quality Benefits conferred by Riverine Vegetation:

A – plant roots **filter out excess nutrients and other pollutants** before they reach the water

B – living/dead vegetation on the ground **helps slow runoff**, intercepts sediment and reduces erosion

C – Roots, as well as other living and dead vegetation extending into the water, **provide surface areas for pollutant-eating microbes**

D – Trees and other riverine vegetation **provide shade** that helps to keep the water cool and dissolved oxygen levels high enough to support trout and other sensitive organisms. Also, **less algae** grows in shaded streams due to the reduced sunlight

E – Leaves, twigs, insects and other natural items (not lawn clippings!) falling off streamside vegetation and into the water help provide healthy fuel for the aquatic food chain

F – riverine vegetation enhances infiltration of precipitation into the ground, where it can replenish aquifers and streamflow. Higher “baseflows” dilute pollutants and mitigate stream heating

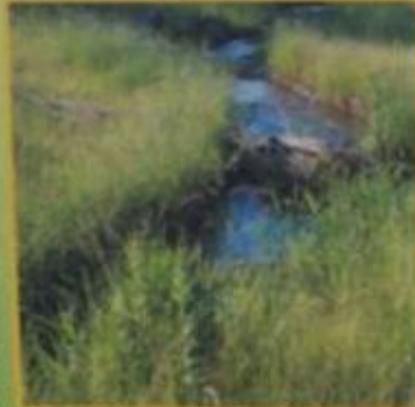
Though this stream has been restored it doesn't appear "neat" and "straight". That's because healthy natural streams are messy, which is what we tried to mimic. Meanders, or curves, allow a stream to dissipate the energy of flowing water and help it move sediment downstream.

Logs and tree roots in the stream provide habitat for fish, turtles, and insects. Grass, shrubs, and trees on the stream bank make cover and food for birds, frogs, snakes, and other wildlife.

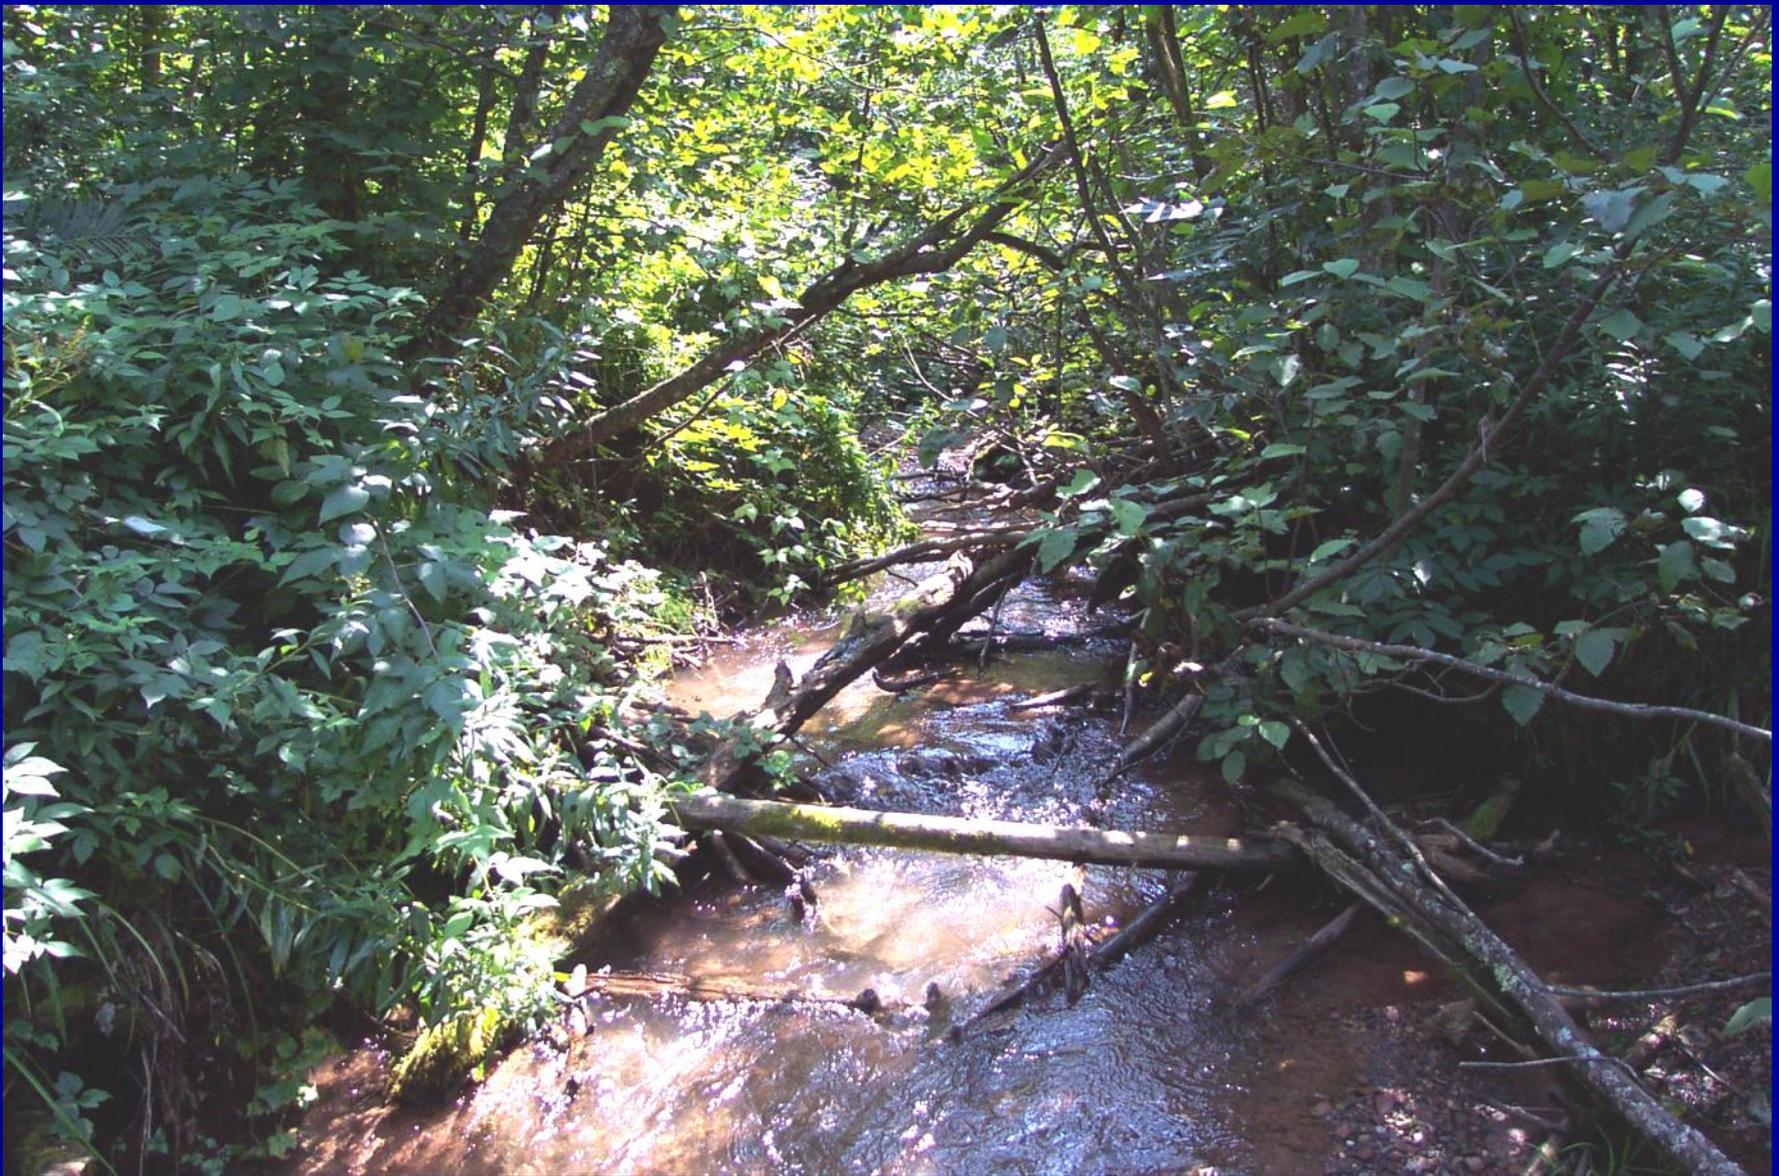
A good example of “Nature is messy”: Large Woody Debris (LWD, also known as “woody habitat”) in a stream, along with lots of streamside vegetation

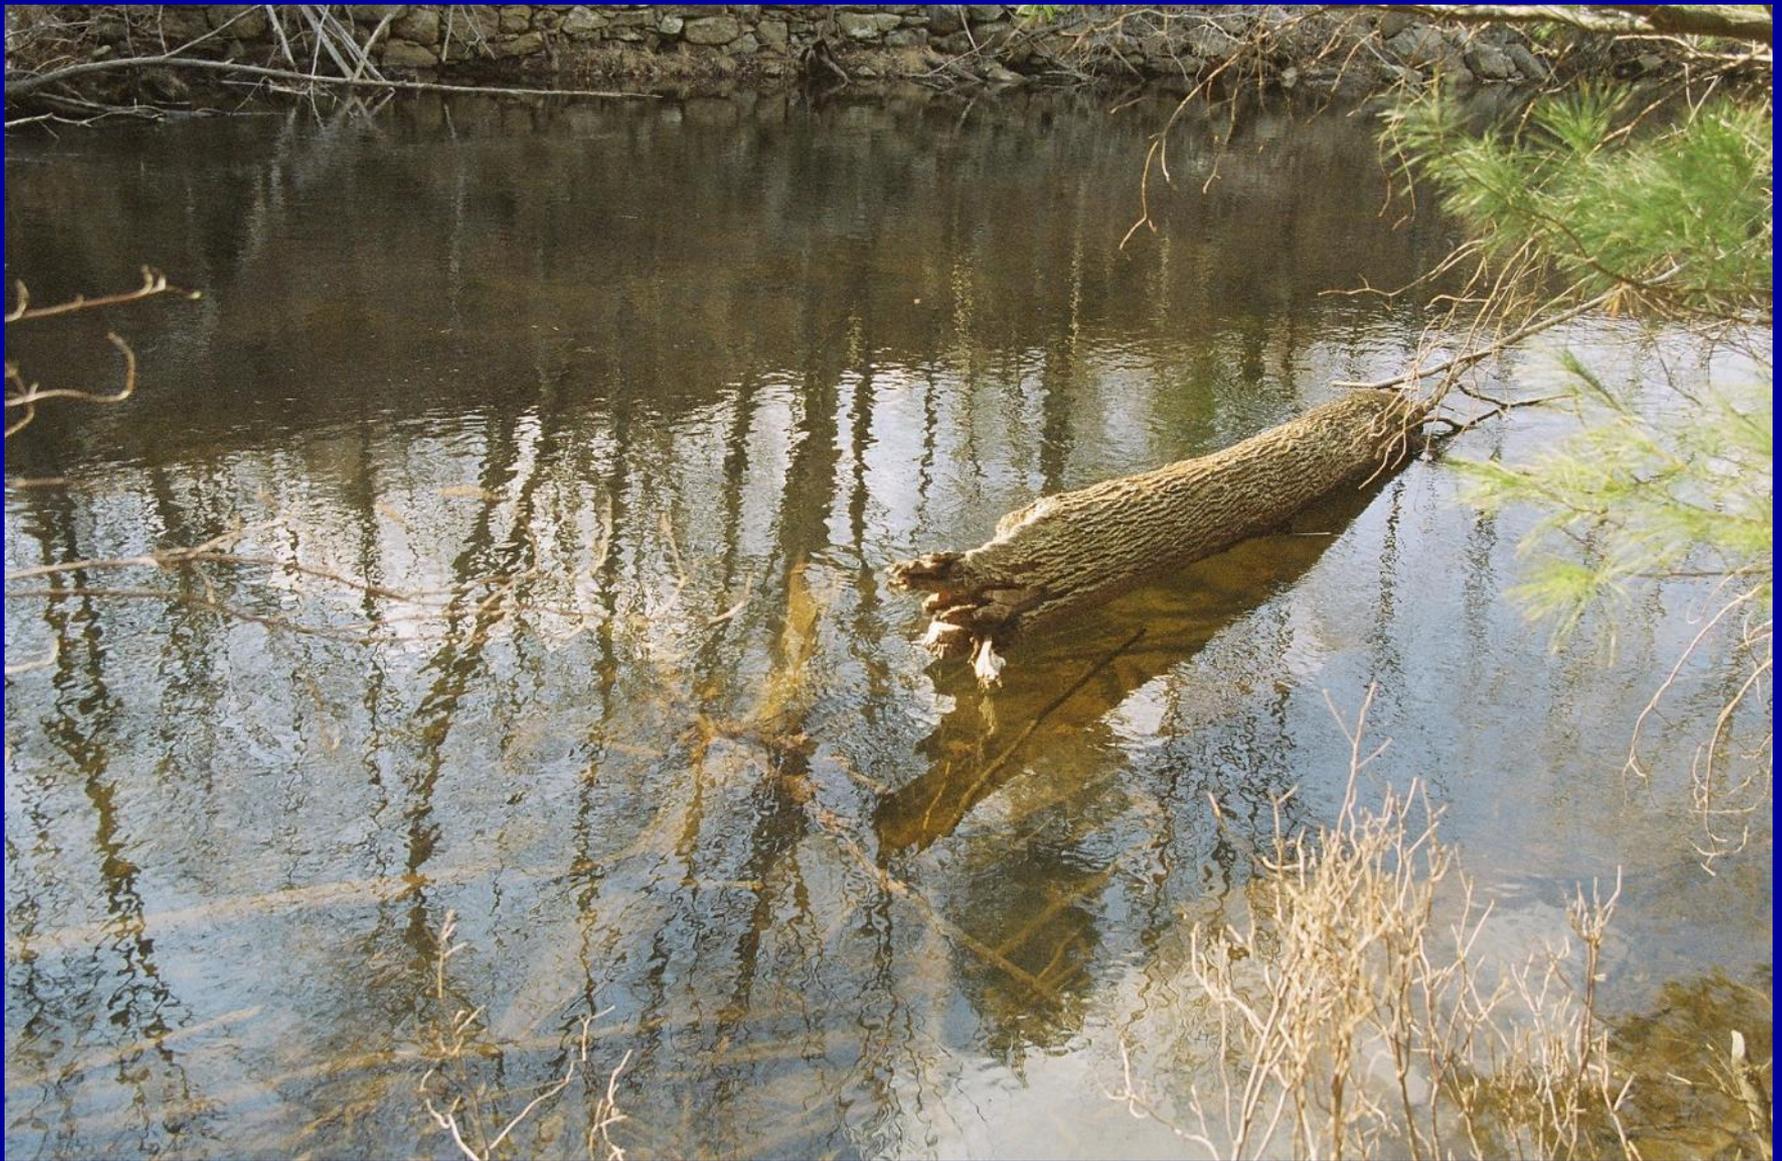
Good example of “structure”: wood above and below the surface of the Quinebaug River in Sturbridge – Anglers know fish are often lurking in such places

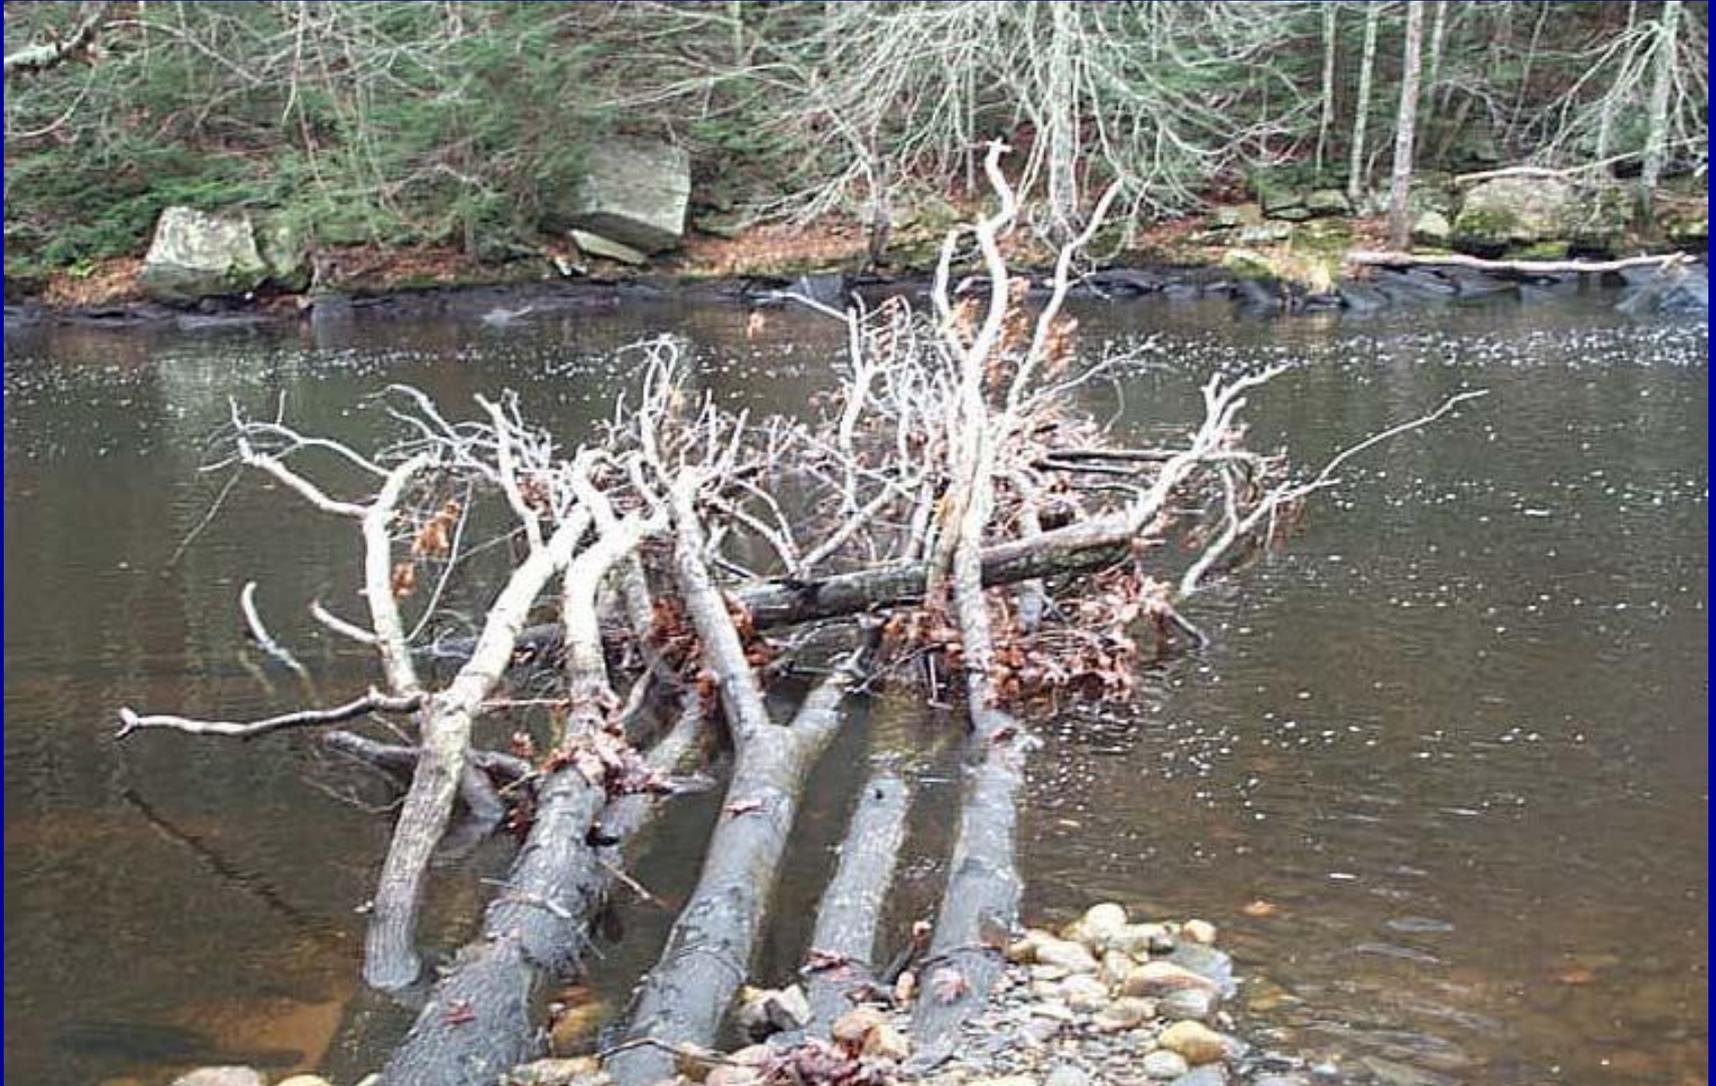
An example from the Shetucket River in Sprague, CT, where the CT DEP installed several “constructed log jams” into the river to enhance fisheries habitat (see <http://www.ct.gov/dep/lib/dep/fishing/restoration/shetucketriver.pdf> for more details)

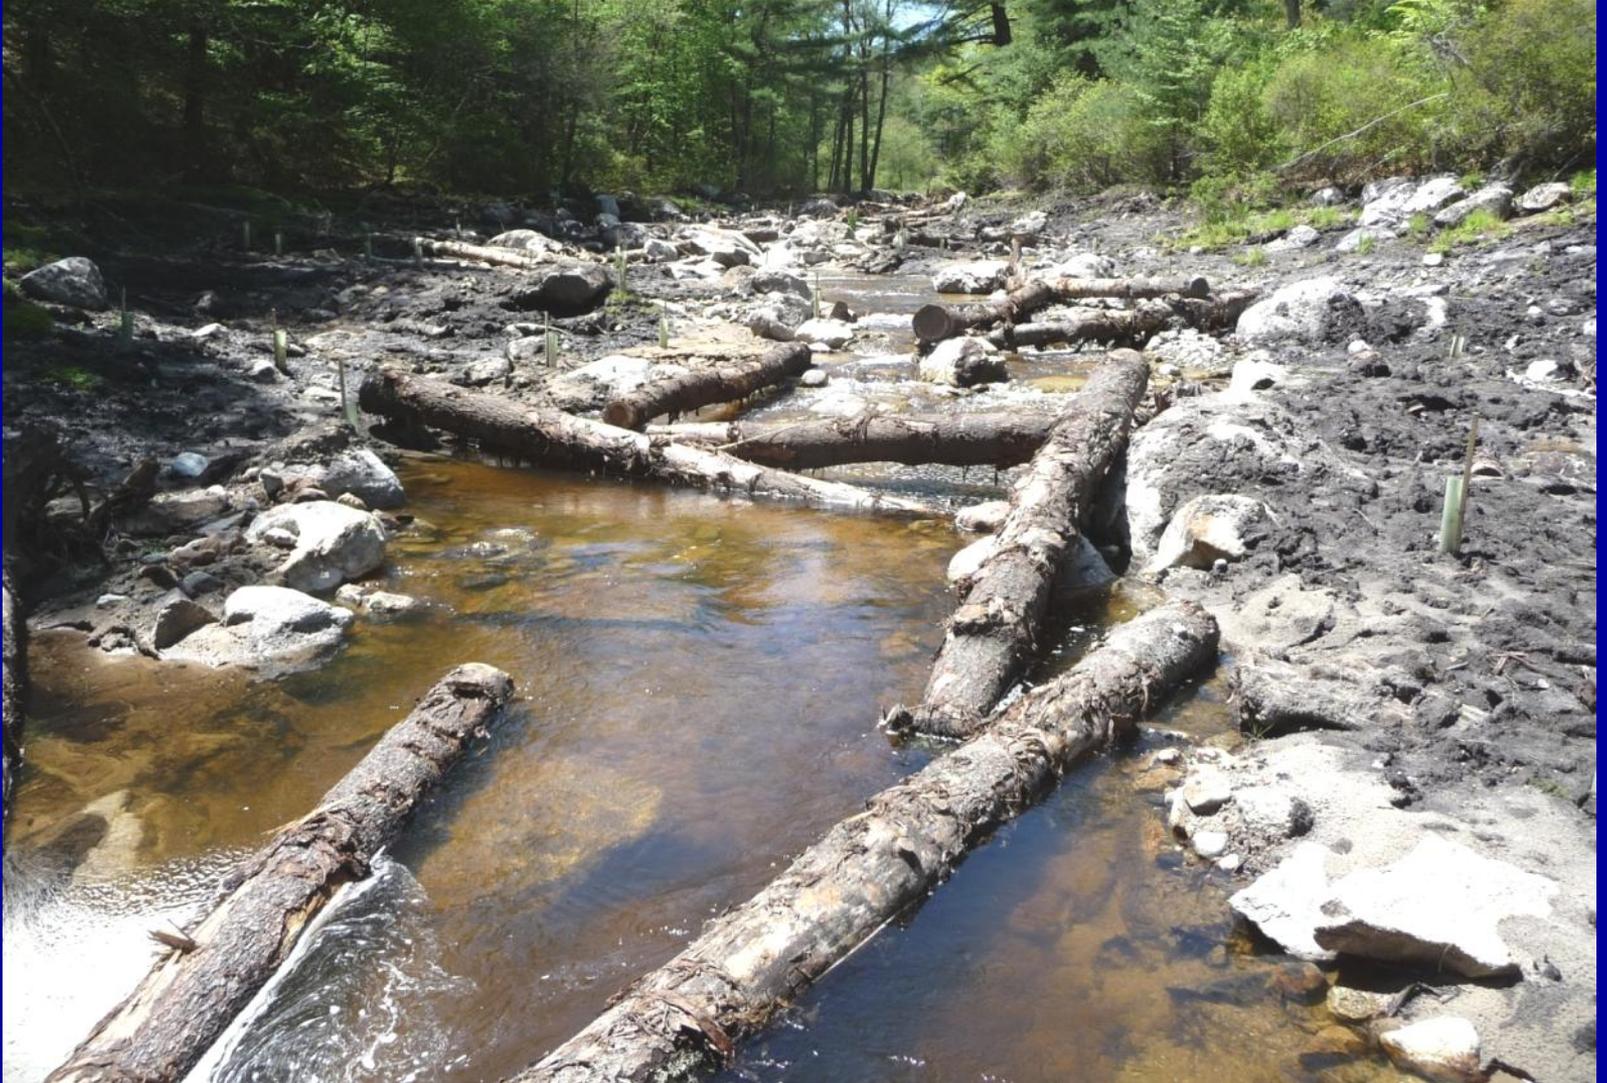
An example from Massachusetts: the Eel River in Plymouth, where the MA Division of Ecological Restoration added logs to a segment of the river flowing through a former impoundment to enhance its habitat complexity - see the link below for more details:
<http://www.mass.gov/eea/agencies/dfg/der/aquatic-habitat-restoration/eel-river-restoration-project.html>

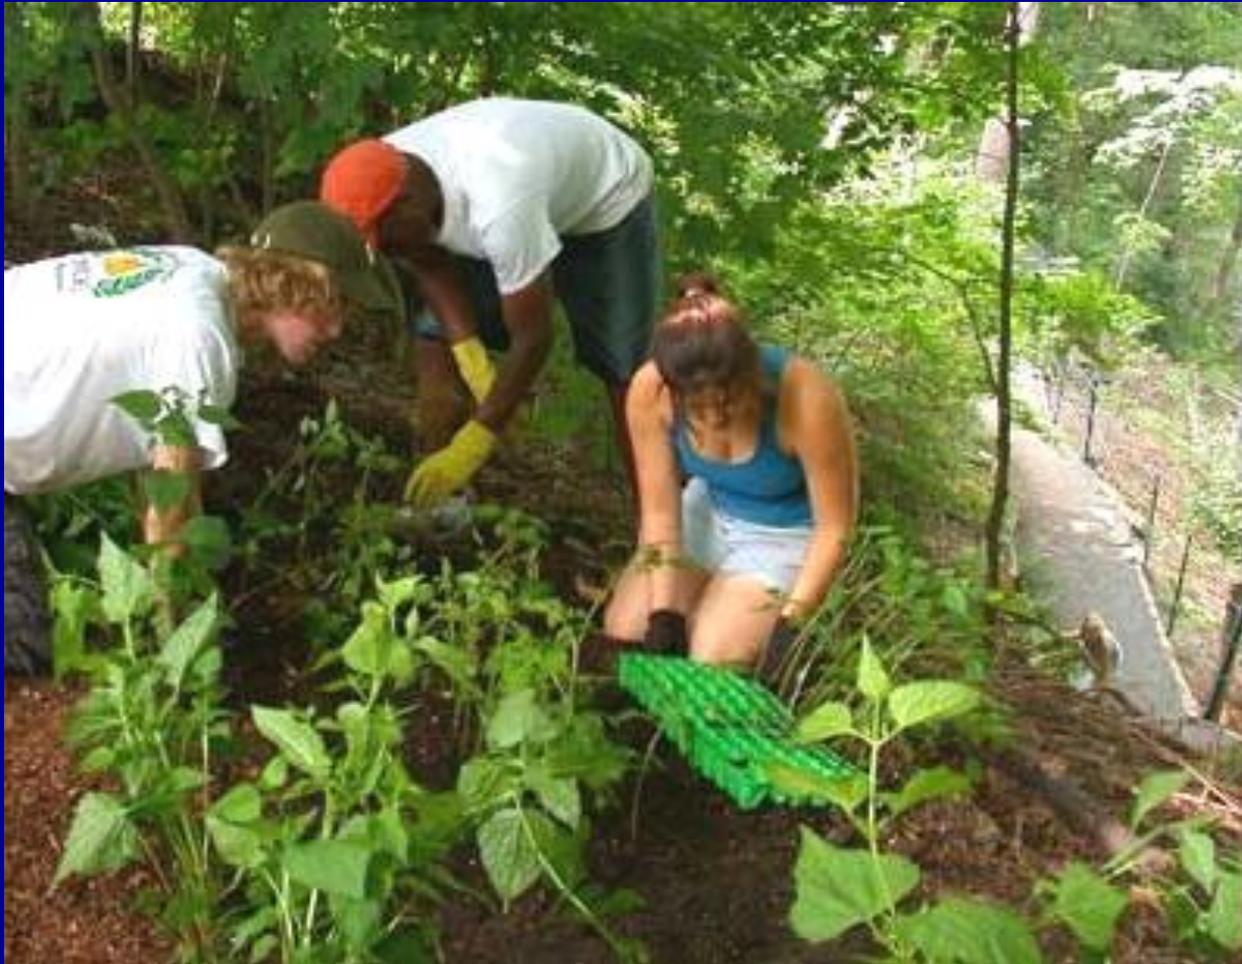
Volunteers planting native plant species along the banks of the Housatonic River in Great Barrington, MA. This planting took place after invasive species (Japanese Knotweed, e.g.) were removed

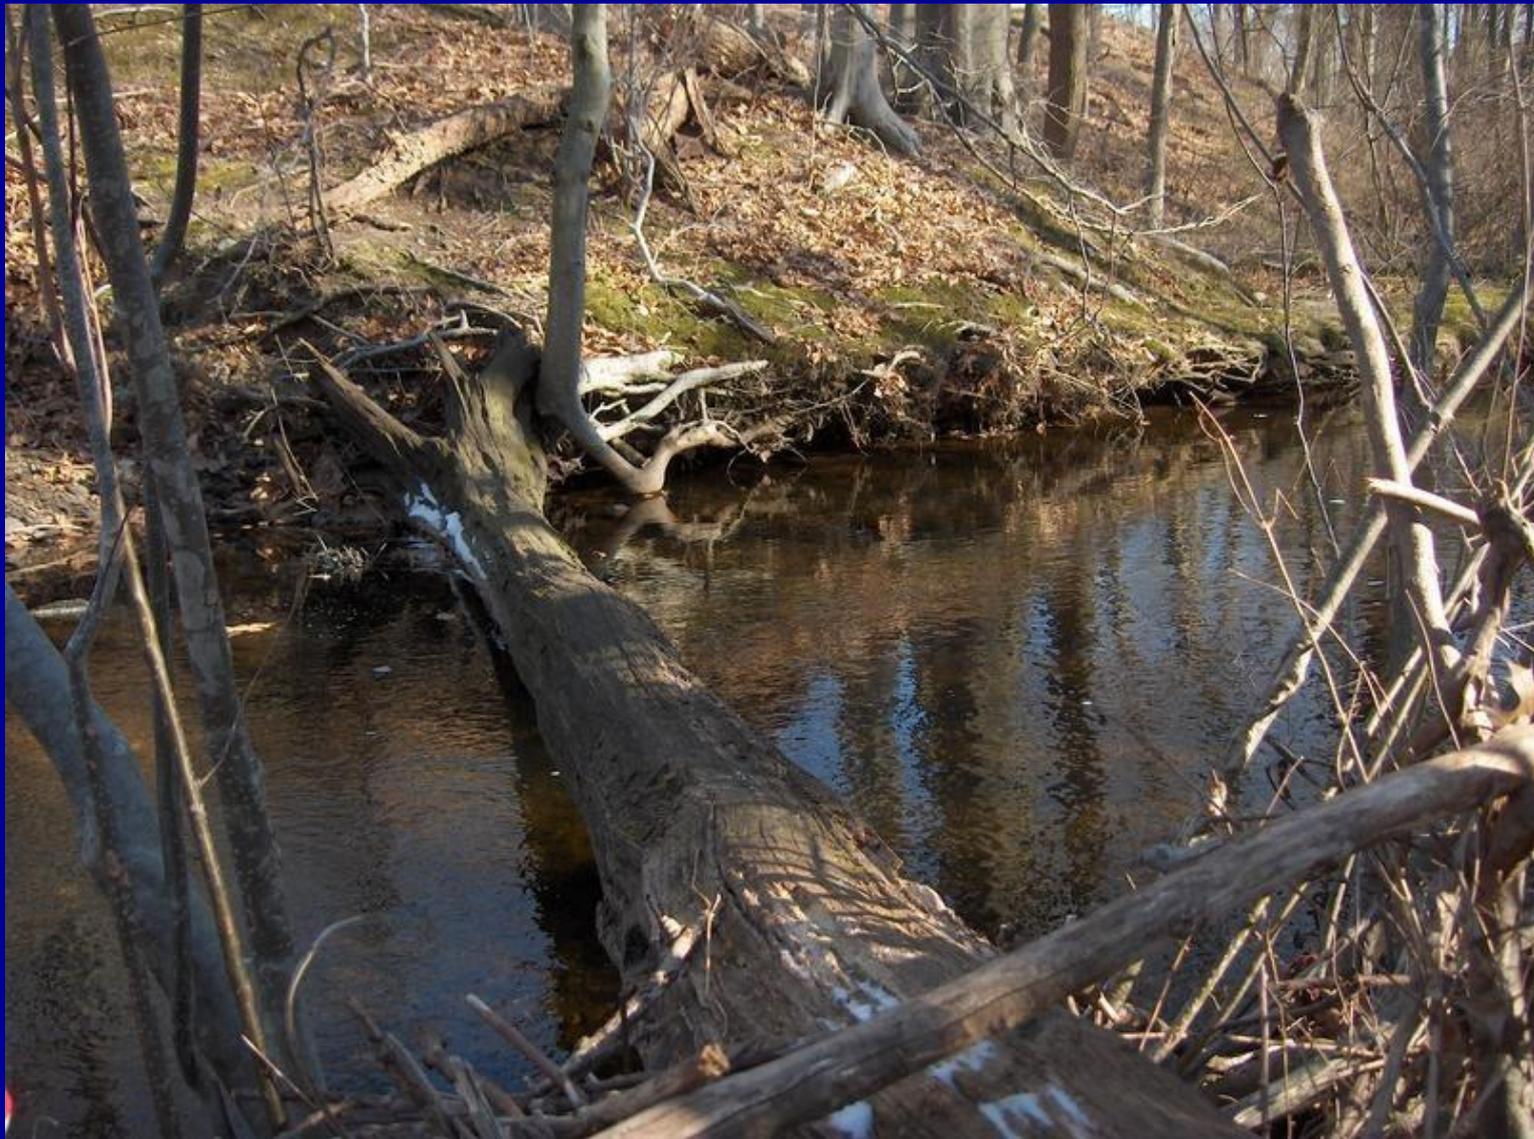
Tree fallen completely across the Squannacook River in Townsend creates an obstacle for paddlers but provides “structure” for fish as well as a bridge for animals (and people).

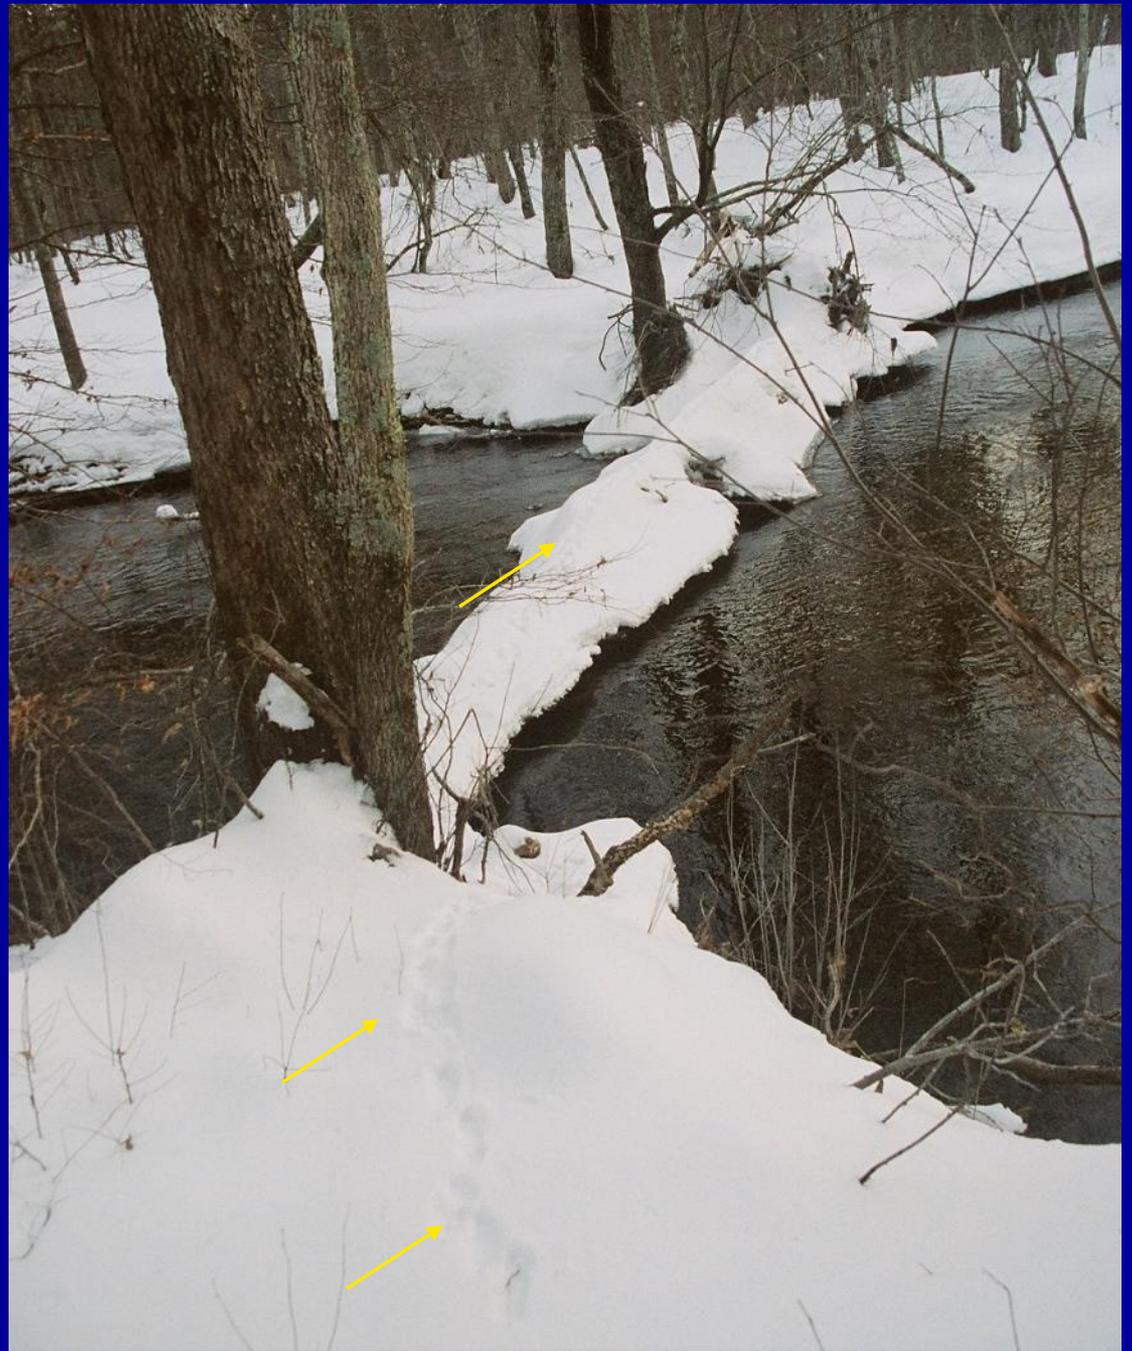
Here's evidence, from the winter, of where an animal (a bobcat?) utilized this same tree fallen completely across the Squannacook River in Townsend to cross the river without getting wet (yellow arrows indicate paw prints heading to and on log)

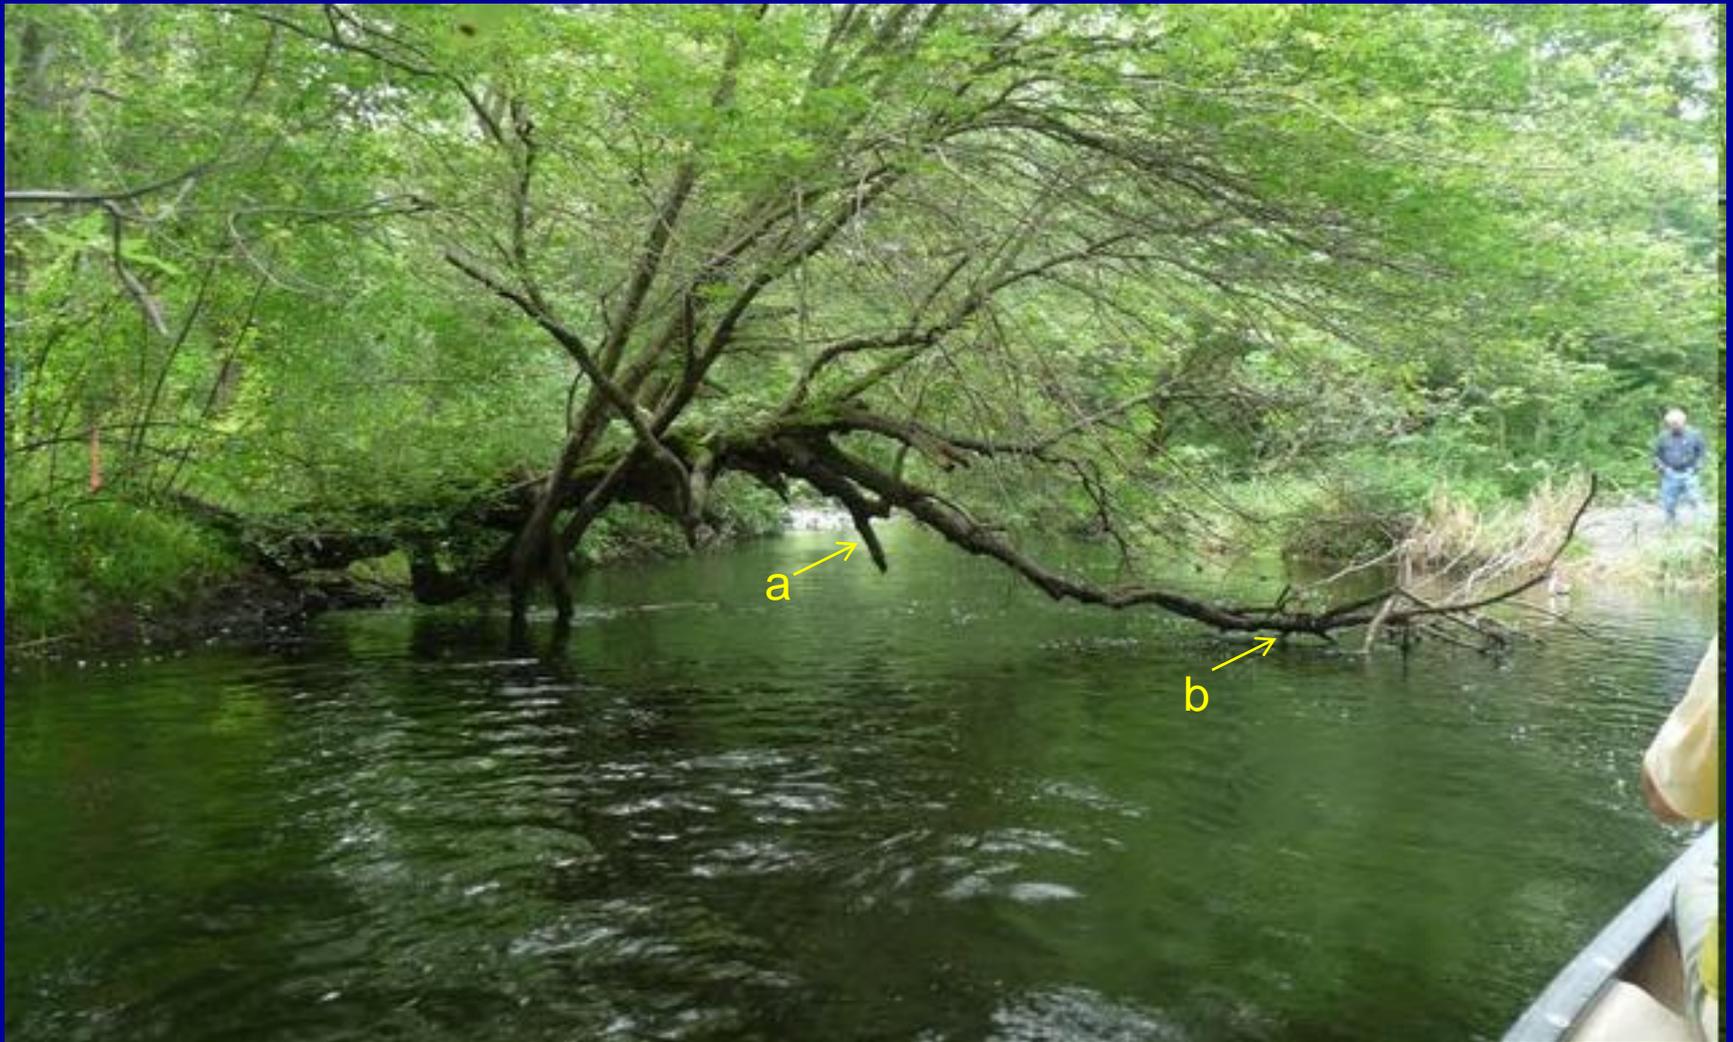
For this tree, overhanging the Town River just upstream from the Bridgewater public access boat launch (where person is standing), the stubby branch remnants under the "arch" portion of the tree (a) could be sawed off to facilitate paddling underneath the arch. Alternatively (or additionally), the last few feet of the branch on the right (b) could be trimmed off, enabling paddlers to paddle around the tree rather than ducking under the arch.

The small branches sticking up in over the submerged portion of the tree trunk in the middle of the channel (see arrow) could be removed to facilitate safe paddling over that portion of the tree without harming the ecological functions of the remainder of the tree.

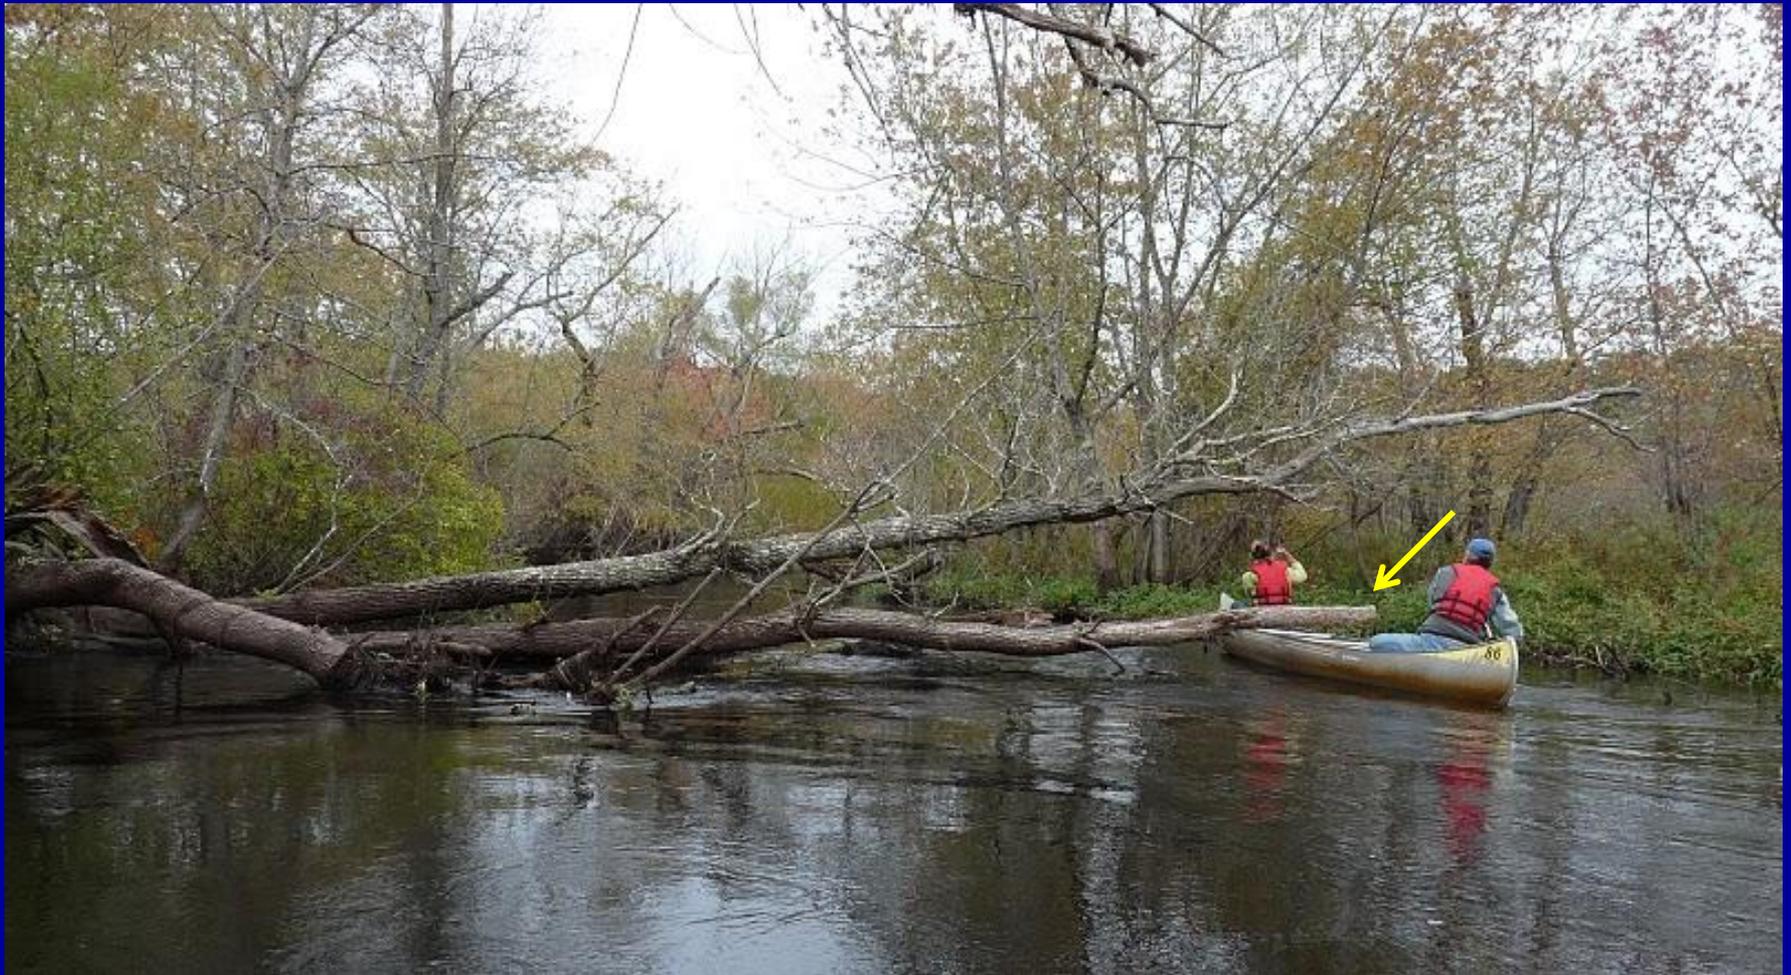
An excellent example of judicious pruning on the Ipswich River in Topsfield, where only a small section of the lower tree limb was cut and removed (see arrow) to enable paddlers to safely avoid the logjam, while leaving the remainder of the fallen trees in place to fulfill their ecological functions and values.

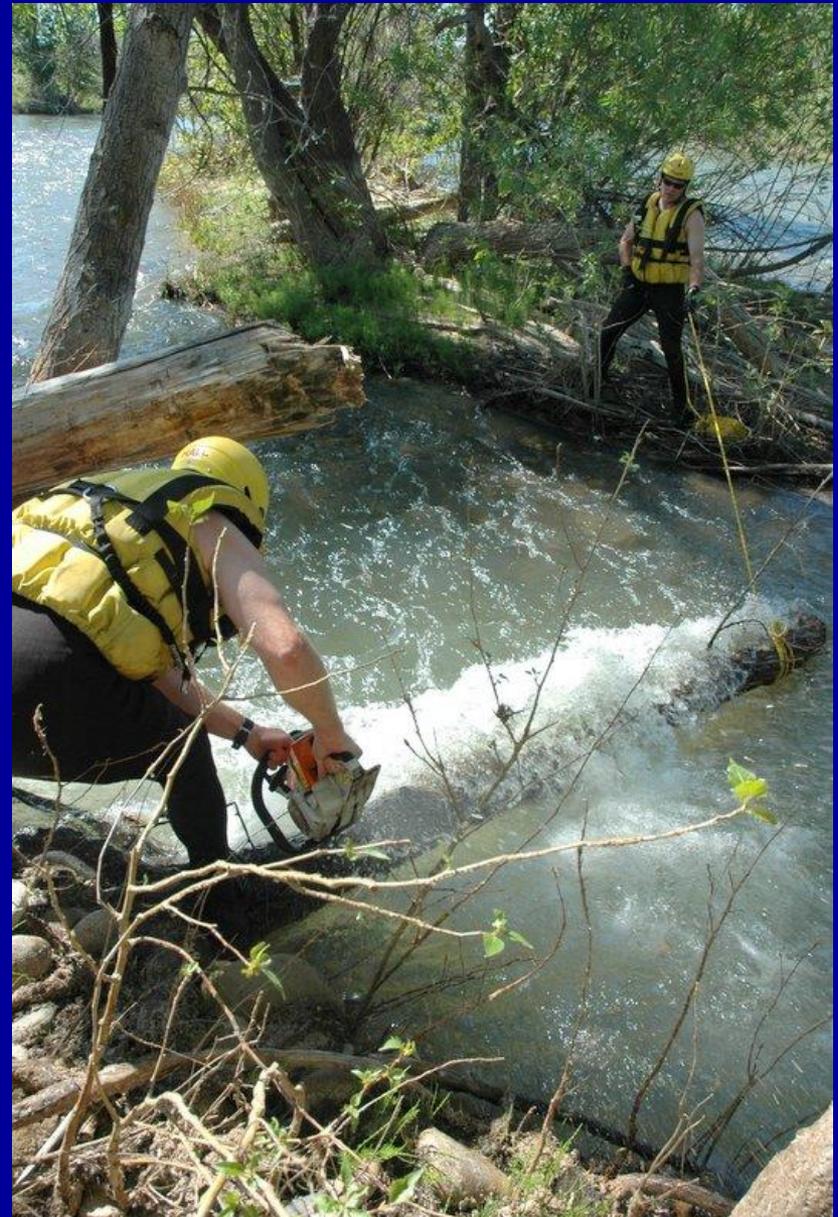
Here's someone operating a chainsaw to remove a section of tree that is blocking a fast-moving section of channel. Note the helmets and PFDs worn by the workers, as well as the rope tied on to the other end of the tree to help secure it. People attempting such work must be fully trained in safety procedures. Ideally, it would have been better to have done this work at a lower flow level.

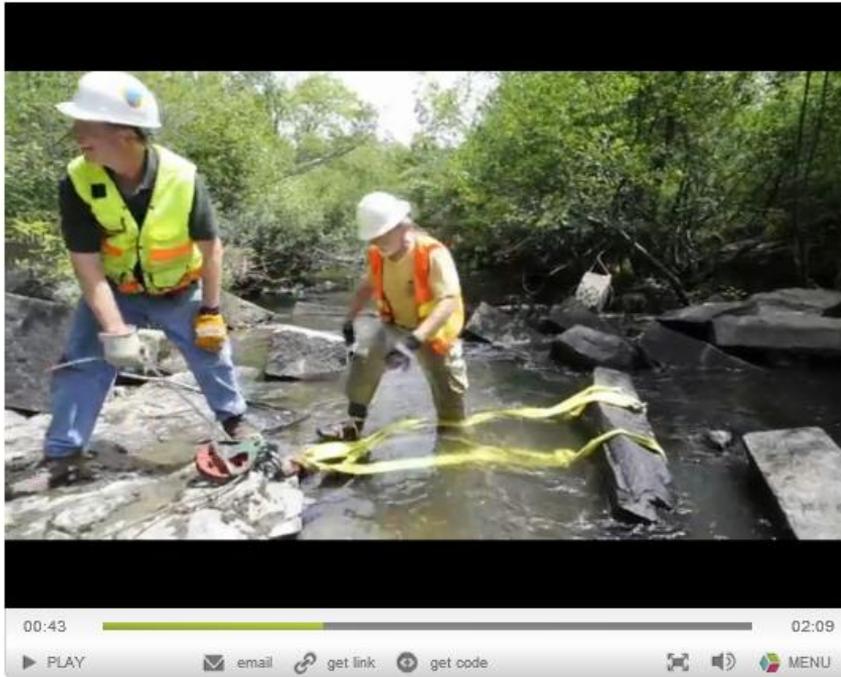
A three-day cooperative effort has begun to remove 25 granite blocks that once formed a dam on the Yarmouth waterway. And advocates hope it's just the beginning.

Here's a story about how a cable winch (also known as a [grip hoist](#) or [come-along](#)) device was used to relocate granite blocks from a collapsed dam to facilitate fish passage. The same technique can be employed to relocate logs in a river to locations where they no longer pose a safety hazard to paddlers.

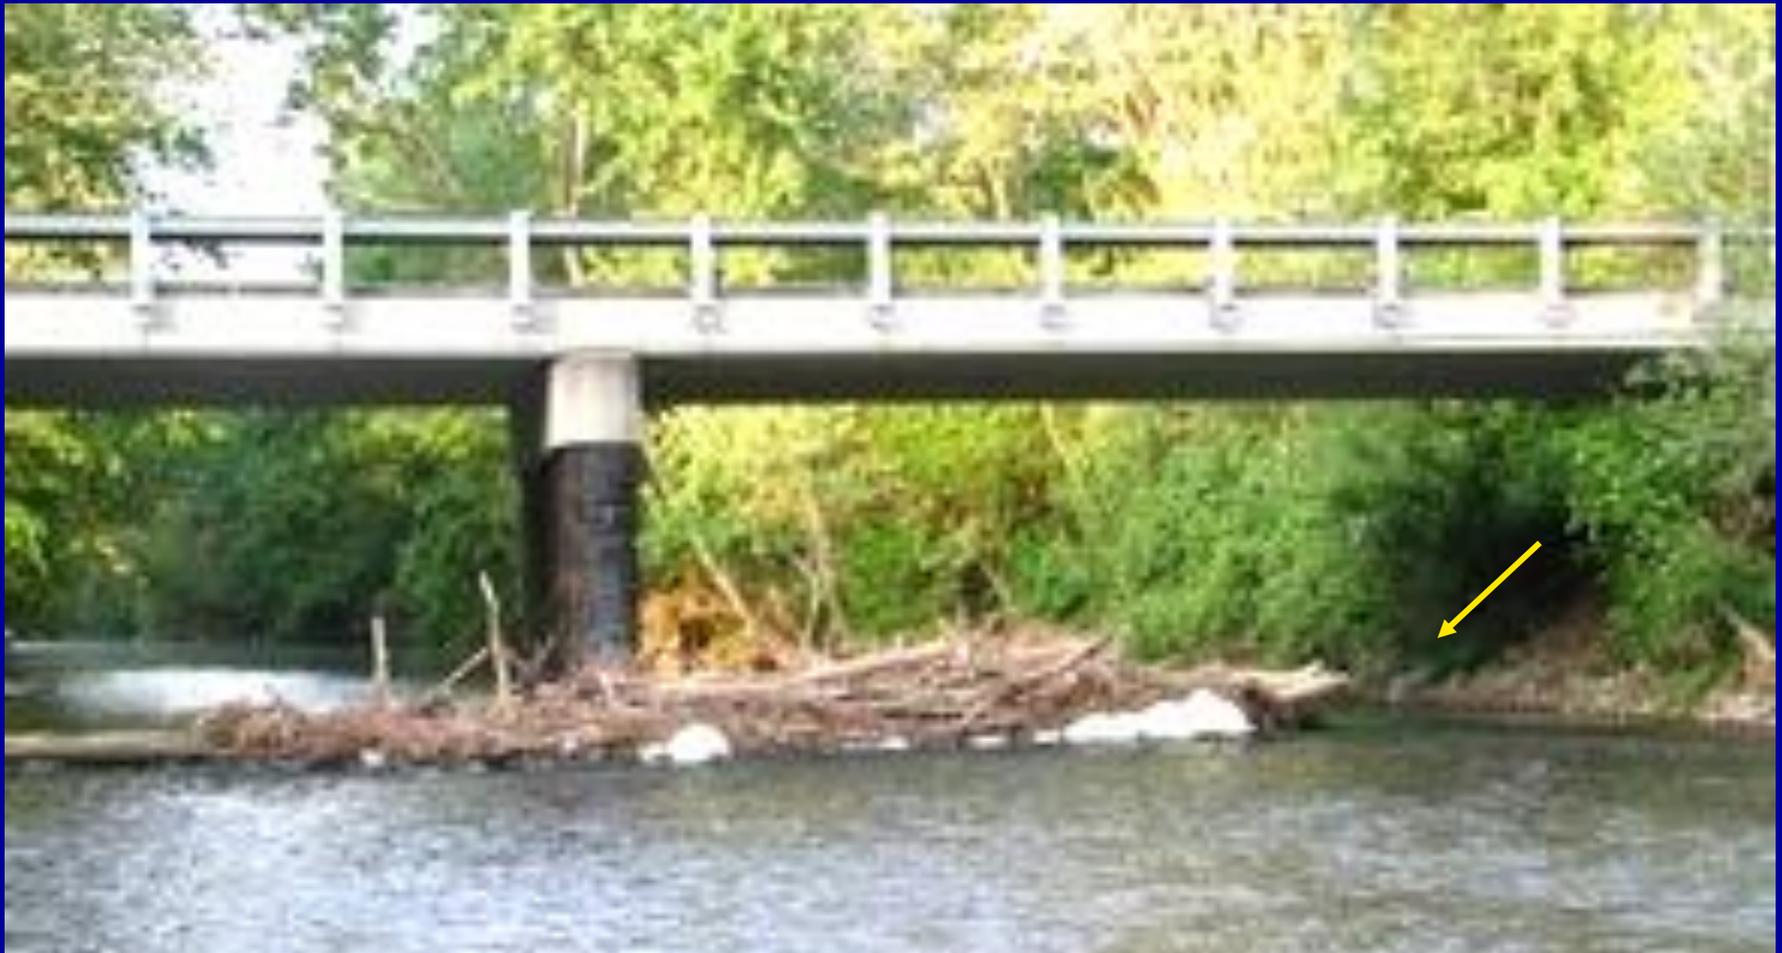
Logs and other debris backing up against a bridge abutment can create a potentially dangerous condition. Although paddlers can currently avoid this obstacle by paddling around it to the right (see arrow), were additional logs or other debris to be backed up here, it could potentially undermine the stability of the bridge and/or cause significant upstream flooding. DPWs may need to act to remove the blockage in such a situation.
