Stream Vegetation & River Herring

Russ Cohen, Rivers Advocate

Mass. Department of Fish and Game

Presented at the 4th Annual Meeting of the River Herring Network

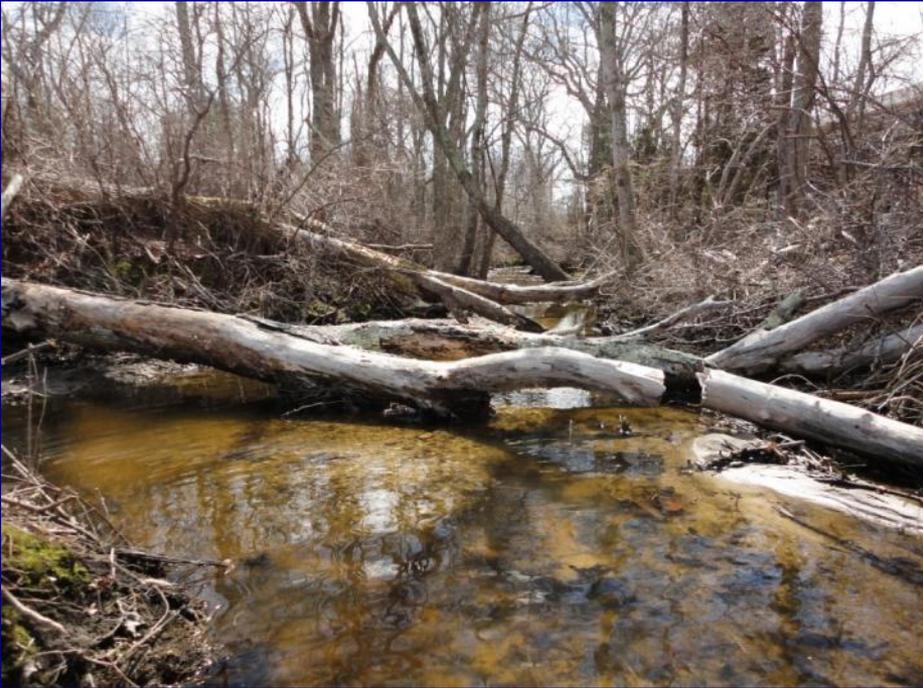
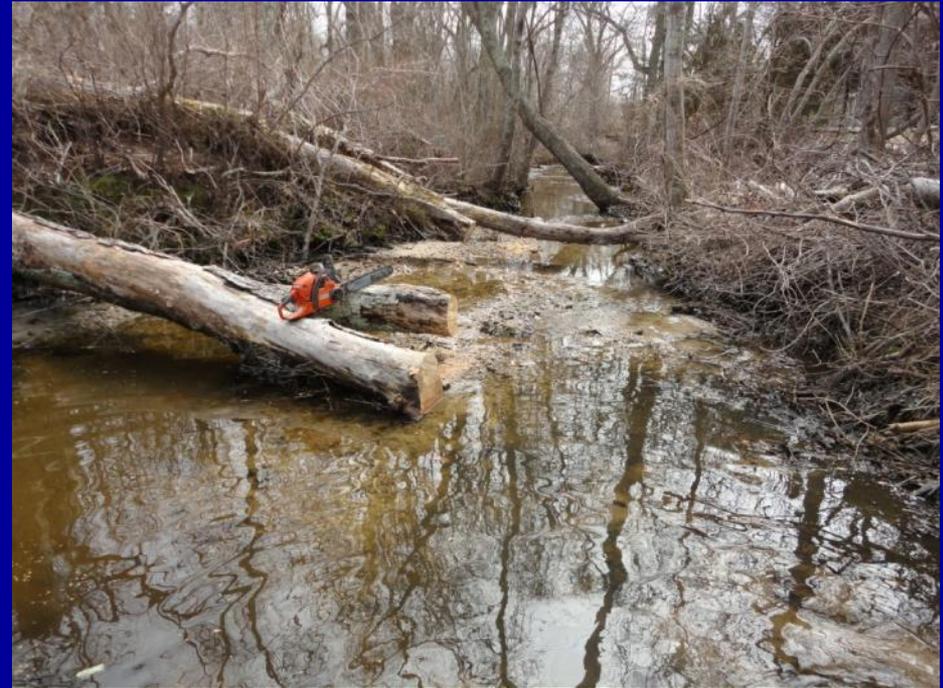
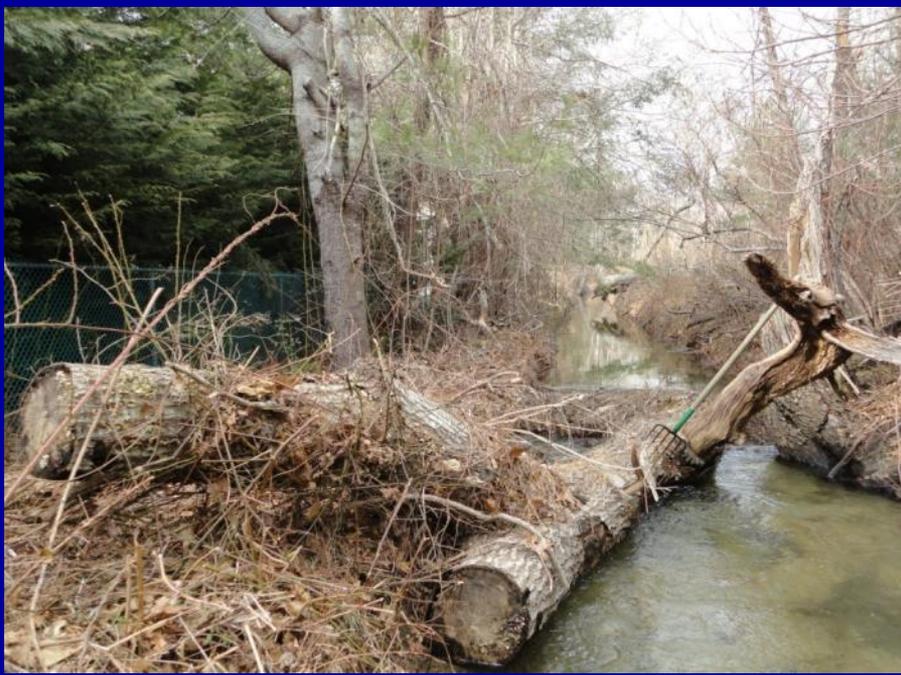
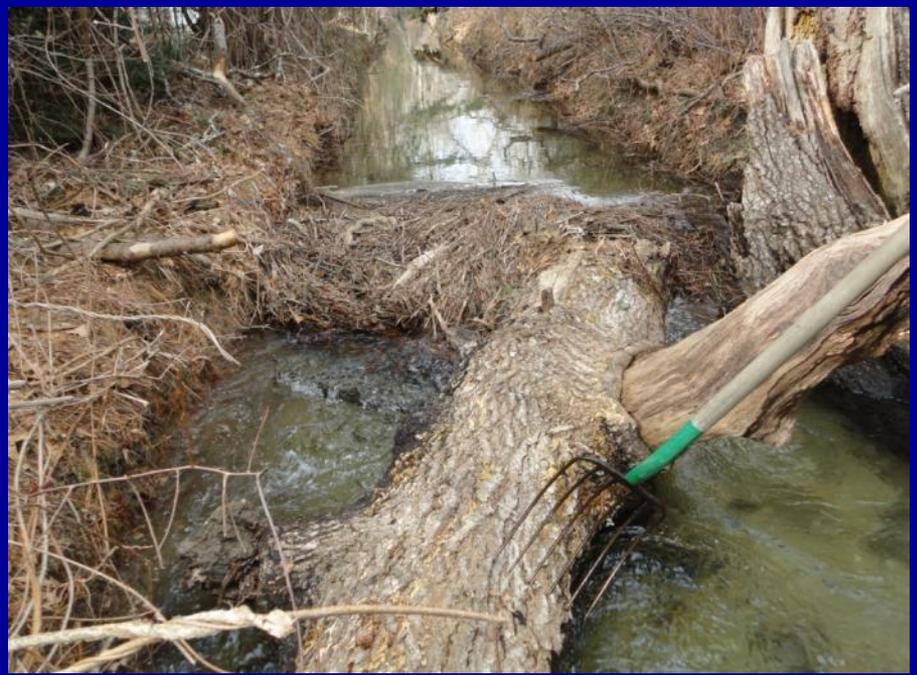
“Before” and “After” photos from the Santuit River

Note what was removed and what was not.

Centerville “before” photos (see above left and right), looking upstream at apparent blockage - but water is getting through (moving underneath) – could the fish as well?

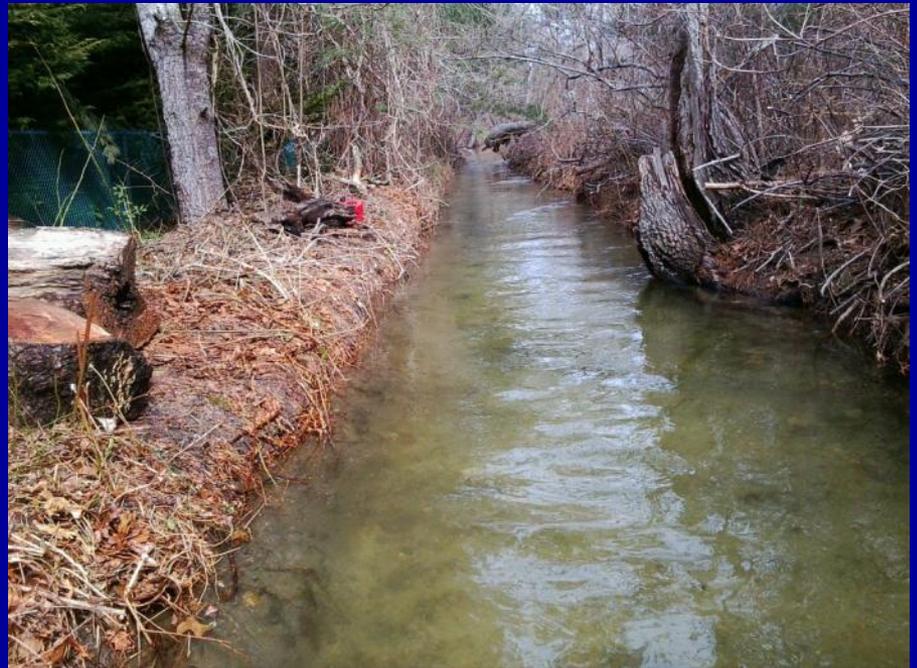
Another example of apparent blockage (below Mill Pond in W. Barnstable ?) - but if water is getting through, could the fish as well? Also note how stream flowing through LWD and stones might affect substrate sorting and deposition, helping to create good fish spawning and benthic macroinvertebrate habitat

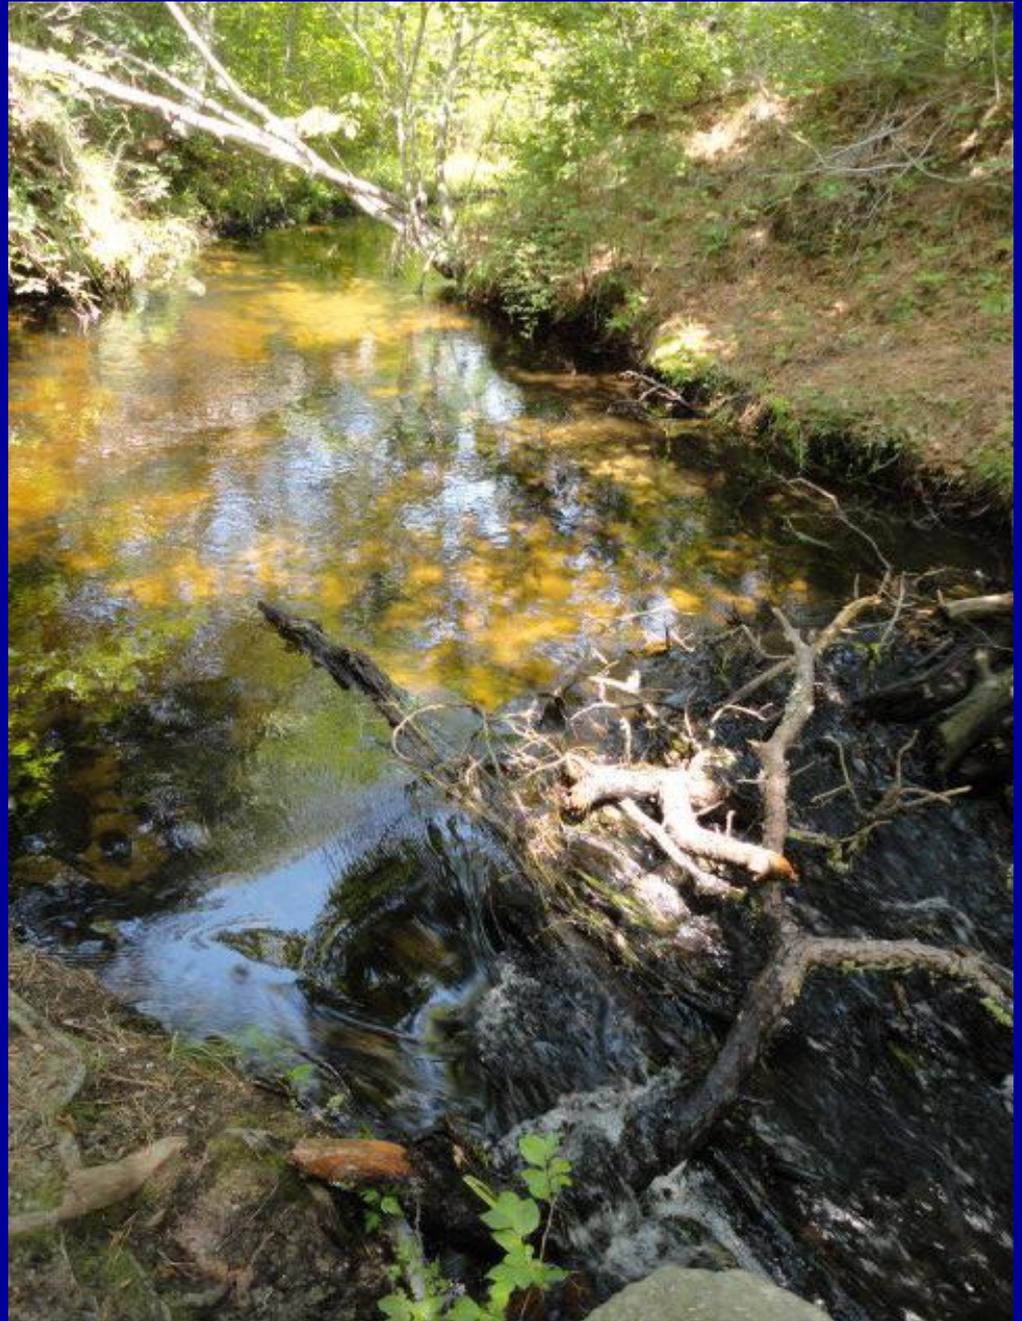
Another example (LWD fallen into the Skunknett River) – does this appear to impede up- or downstream fish passage?
